AN ENGINEERED METHOD FOR INSTALLING REFRACTORY IN CORELESS FURNACES

Gradmatic Equipment Inc.
Bala, Ontario, Canada
December 7, 2020

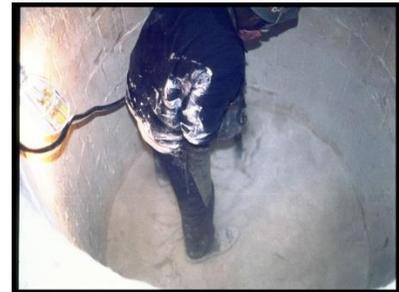
The most common method used to compact the bottom material is a hand-held tamping vibrator.

The worker enters the confined space of the furnace to ram loose silica until the surface is solidly knit. Depending on the size of the furnace, this activity can be lengthy, exceeding one hour, exposing workers to airborne dust and repetitive-strain injury.

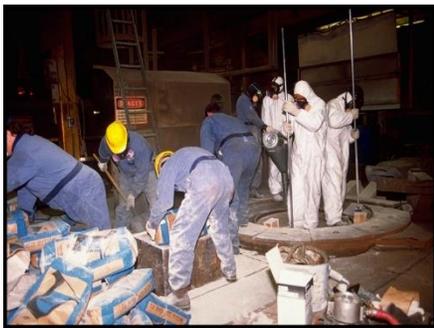
Sidewall Material: A variety of methods are available to install and vibrate sidewall material, the objective being achieving optimal material density.

Typically, layers of material are added to the furnace either by dumping individual bags of material or by pouring sacks of material

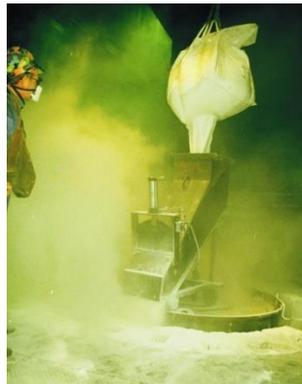
Some foundries use a funnel-type apparatus to install the material in the sidewalls.

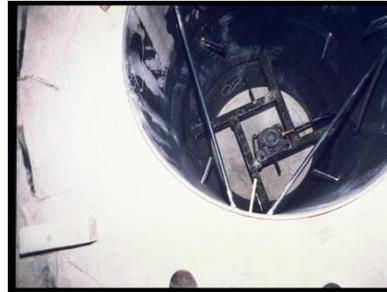
The process is completed by applying one of several types of vibration directly to the internal form causing the material to compact once installed in the annular area.

One application uses a quadrant bolted to tabs at upper and lower positions of the form. A single vibrator is moved around the frame for four periods of vibration.

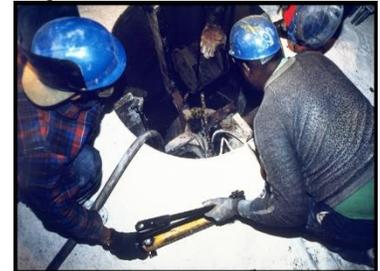
Workers enter the confined space of the form to attach the quadrant at various levels and again to move the single vibrator to each of the four quadrant locations. A second application uses a single vibrator attached to an expanding cross system attached to wooden battens. Depending on the size of the furnace, vibration occurs at one or two points of the length of the furnace form. A third type of vibration system vibrates the internal form with a single vibrator bolted to tabs welded to the former at two locations. Variable frequency action is applied to compact the material.

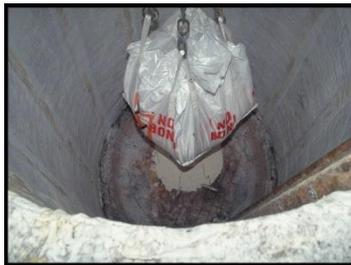
Installing the Furnace Bottom Material: The automated method of lining a coreless induction furnace is a series of processes that begins with adding material

to the furnace bottom. Bulk bags of refractory are lowered by hoist, onto the furnace floor. Very little dust is emitted from the bulk bag using this method provided the elongated sleeve of

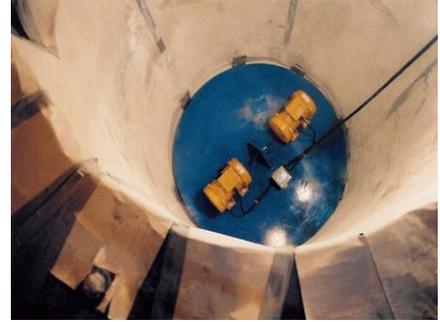
Furnace Bottom Vibration: The entire bottom of the furnace is compacted in one operation using a vibrator plate, equipped with two electric vibrators. The plate is lowered by hoist on top of the material and vibrated for approximately twelve to sixteen minutes depending on the size of the furnace, producing a solidly knit base. Vibration is performed by the furnace operator using a control stand, from the furnace deck.

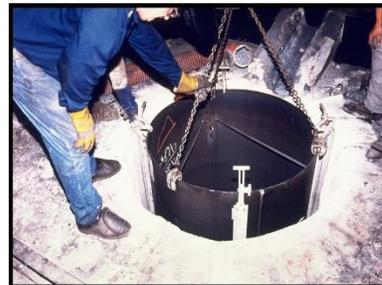
Each tool is suspended between the form and furnace at equal, circumferentially spaced locations. The tools are individually adjusted and locked in place at equal

amounts to set even spacing between the form and furnace sidewall. Once all tools are set at equal distance, the form is centered for its entire length and is lowered to the furnace floor.

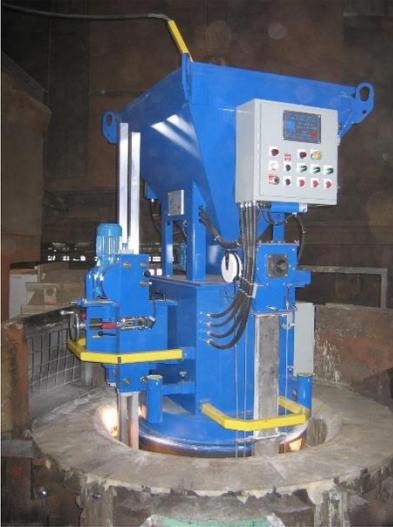
Lining Furnace Sidewalls Using the Refractory Installation System (RIS): For purposes of clarification, the Refractory Installation System (RIS) serves two functions. It dispenses dry refractory into the annular space between the furnace wall and form and simultaneously performs the de-airing or forking function.

When the furnace form is placed and centered, the RIS is set on top of the free-standing form using an overhead hoist. After positioning, hydro is connected to operate the machine. Individual bags of material have been replaced with specially designed “super sacks” of dry refractory designed according to the amount of material required.

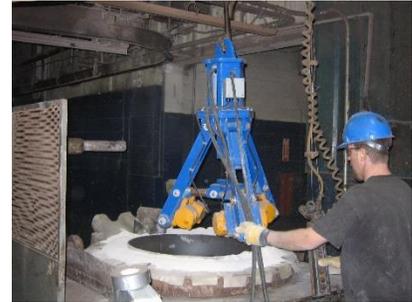
achieving maximum lining life. The legs are adjusted against the angle of the form taper using the control stand to ensure that contact is

sustained during vibration. The majority of the vibration time is focused in the tapered area to reduce or eliminate the likelihood of “elephant’s foot” erosion. The machine is then slowly raised up the internal form, ensuring equal treatment for the entire length of the form. Total vibrating time ranges from fourteen (14) to twenty (20) minutes depending on the furnace size.
